SB 75-0023 R00 AIR SYSTEM - COMPRESSOR VARIABLE GEOMETRY ACTUATOR COMPONENTS (75-30-01) - MASTER COMPRESSOR VARIABLE GEOMETRY ACTUATOR AND SLAVE COMPRESSOR VARIABLE GEOMETRY ACTUATOR ONE-TIME INSPECTION

Issued: 11/02/2021

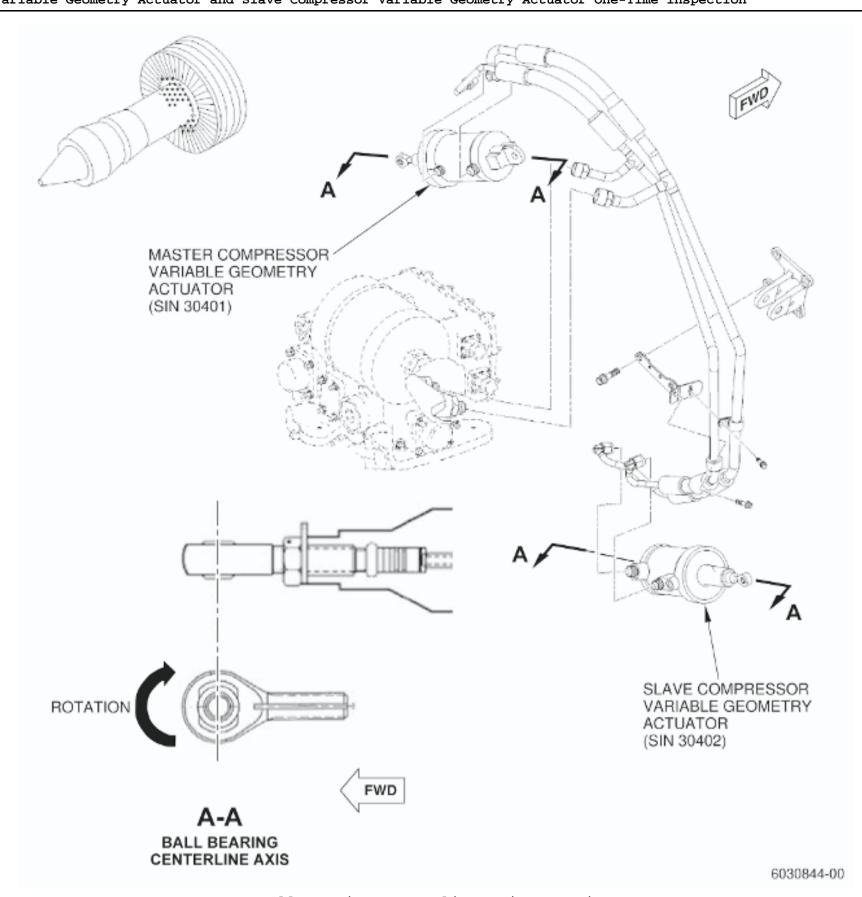
Ball Bearing Hand Clamping Figure 2

- (d) Clamp the two sides of the rod end ball bearing with your index and thumb while you firmly attach the position of the master compressor variable geometry actuator (SIN 30401) with the other hand. Refer to Figure 2.

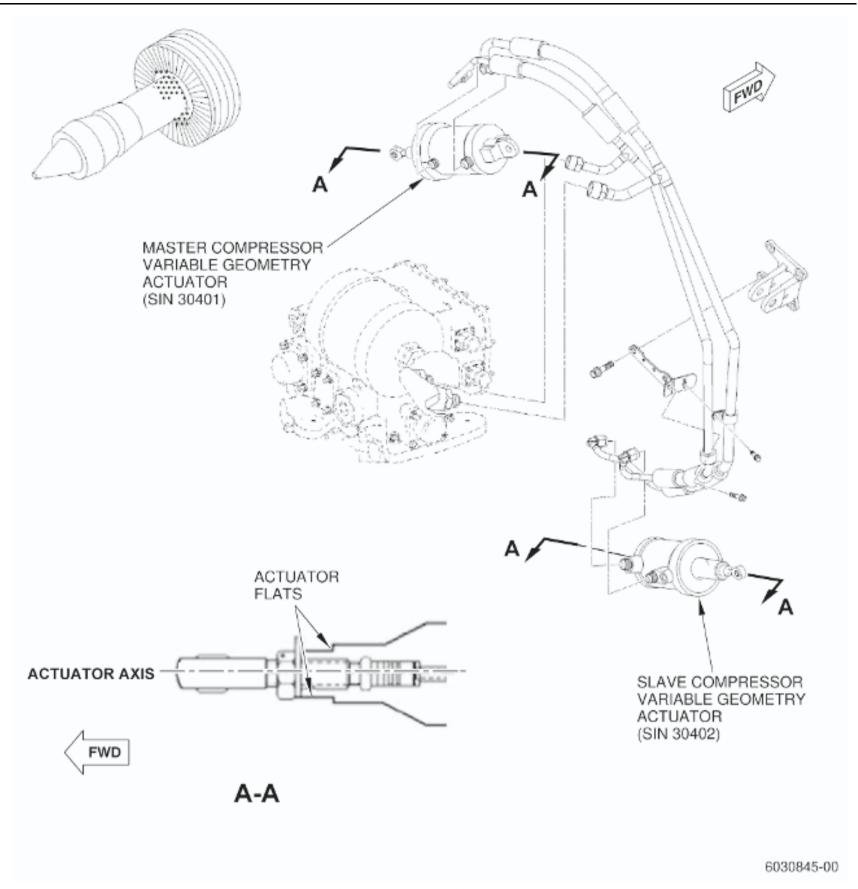
Ball Bearing Centerline Axis Rotation Figure 3

- (e) Try to turn the ball bearing on its axis (clockwise or counterclockwise). Refer to Figure 3.
- (f) Try to turn the ball bearing in the master compressor variable geometry actuator (SIN 30401) axis while you hold the master compressor variable geometry actuator (SIN 30401) flats with a wrench. Refer to Figure 4 and do as follows:
